# THERMOGRAPHIC SURVEY FINAL REPORT

Prepared for  
**Invensys PLC**

Site Inspected:  
**Invensys Controls South America**  
Br 116, Km 33  
Vacaria RS, Brasil

Inspection Date: June 18, 2010.  
Report Date: July 1st, 2010.

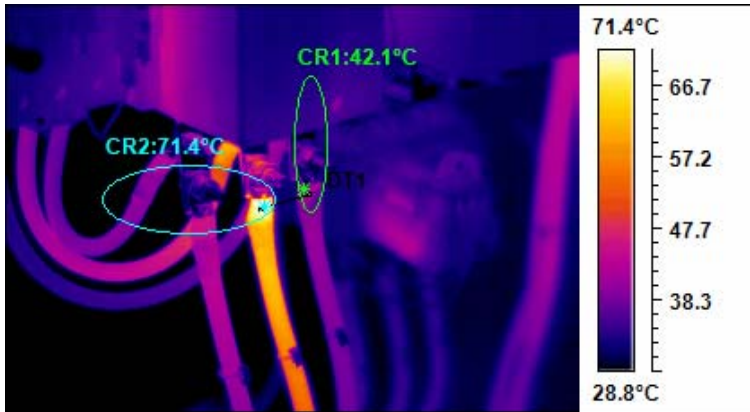
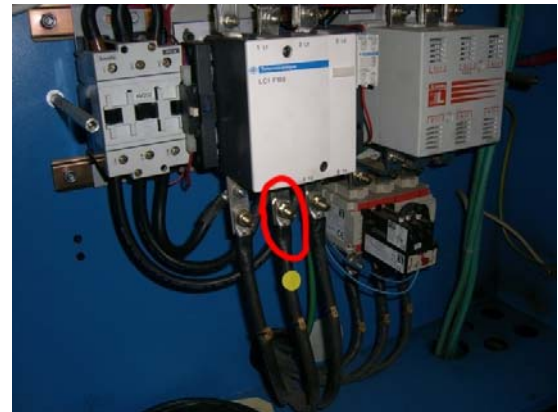
**Finding # 1**

Temperature Rise: 29.3 °C

Risk Classification: **Low**

Location: Compressors room

Equipment Description: Air compressor CAC009

Observation: Hot spot on connection phase L2 main contactor.

Probable Cause: Loose connection.

Object Parameter	Value
DT1:Temp-A	41.3°C
DT1:Temp-B	70.6°C
<b>DT1:DeltaTemp</b>	<b>29.3°C</b>

Recommendation	Date Scheduled	Repaired by	Closure validation
Clean and tighten.	06-18-10	Santin D P.	Closed. Was reinspected by Infratherm 6/18/2010
Schedule in periodic maintenance program.	Annually	Elias Ocanha	Regular inspection signed by site leader.
